ERRORS FOUND IN THE CORVAIR SHOP MANUALS

Edited by Bob Helt with help from Kent Sullivan and others

Note in the following, S/B means should be.
Revised 1 Nov 2015

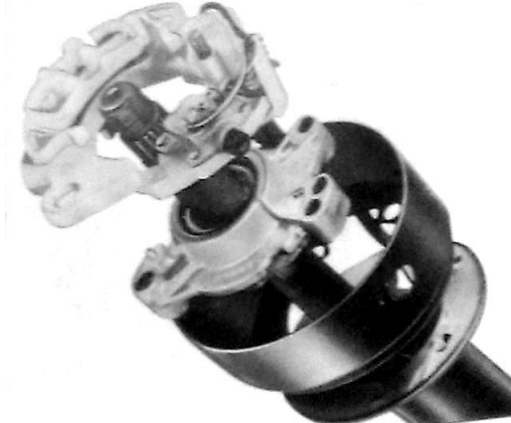
99		9-4, 12-3 &12-4	Directional Signal housing	Likewise, no mention is made of the circular plastic dust shield that sits on top of the switch, just underneath the cancelling cam (nor is it shown in the exploded view diagram). This shield is also shown in the assembly manual.
100		9-4, 12-3 &12-4	Directional Signal Assembly	No mention is made, either, of the round retaining ring that is about 1" lower on the steering shaft than the "C" clip (#13 in exploded view diagram) which retains the thrust washer, wave washer, and upper bearing support (nor is it shown in the exploded view diagram).
101		12-3	Directional Signal Assembly	Shows both the Boyne (left).and Delco (right) switches. Only the Boyne switch was used in the Corvair, so it's misleading to show both. Perhaps this photo was

102	12-4	Directional Signal Assembly	<p>repurposed from a car line that used both. Also, the photo is printed upside down (putting the hazard flasher knobs incorrectly on the left).</p> <p>Boyne switch picture is reversed The picture is printed reversed left-to-right putting the hazard flasher switch on the left again. S/B as shown below.</p>
